SEPTEMBER 2020

BUILDING CONDITION ASSESSMENT REPORT (SUPPORTING MATERIAL FOR TDR/TDP
CERTIFICATION REQUEST)

UNIVERSITY METHODIST EPISCOPAL CHURCH/VINEYARD CHURCH

4142 Brooklyn Ave NE

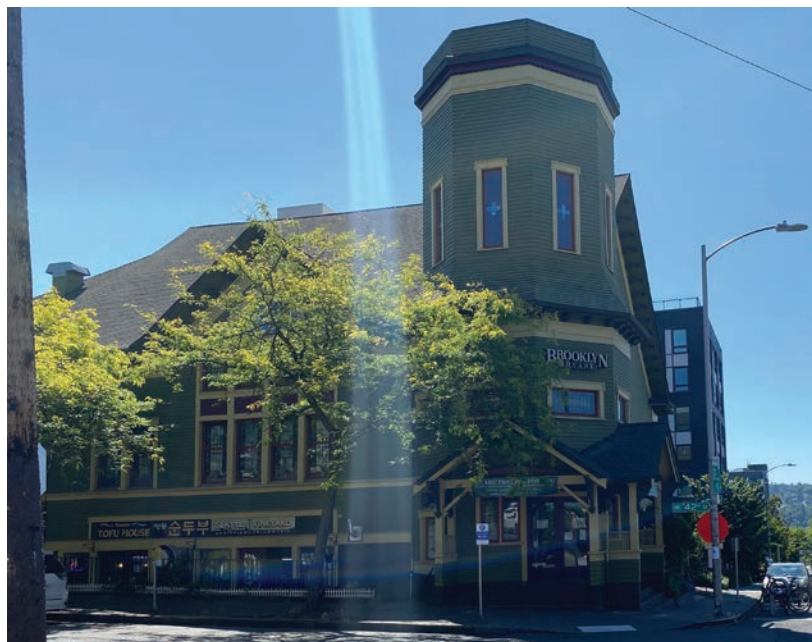
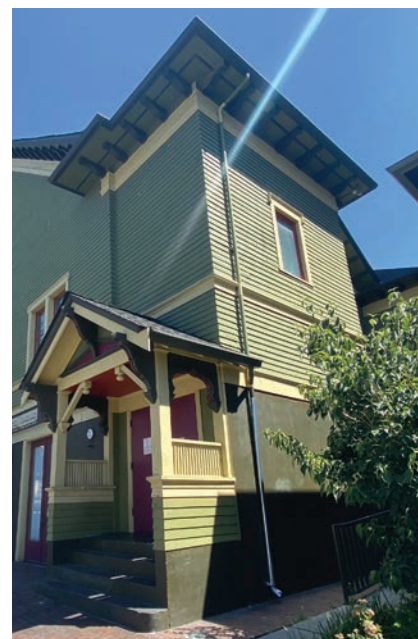
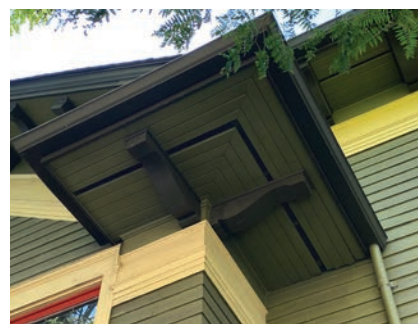
Visual assessment of the roof, gutters, and downspouts indicated that these materials were in good condition and well maintained.

Church records indicated the roof was replaced in 2012. The roof replacement included the removal of leaking skylights.

Church records and scheduled maintenance indicated routine inspection and tasks related to maintaining the roof and gutter system. All evidence points to frequent inspection of the roof surface and frequent gutter cleaning. In addition, all soffits have been painted, venting maintained, and original brackets are intact.

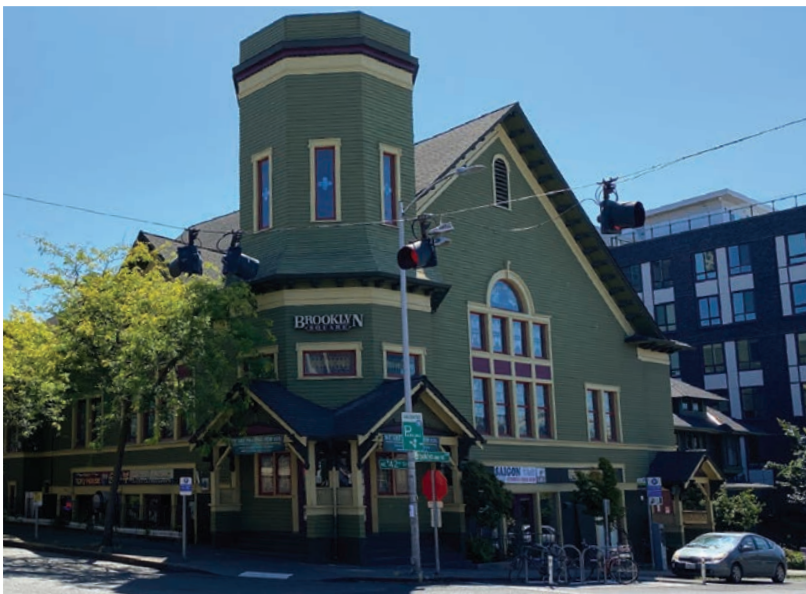
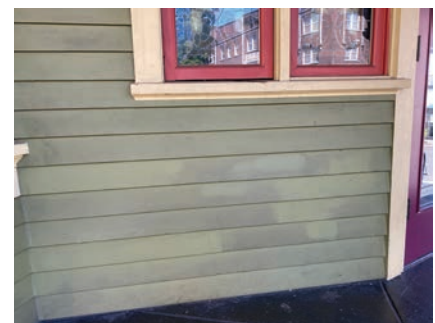
The existing painted cedar siding is in fair to excellent condition, depending on the location of the siding on the building. Overall the siding is in good condition. One of the key factors in maintaining wooden siding is maintaining the paint finish.

The paint finish is now green color. Evidence at porches and the main floor indicates this color has been touched-up to cover graffiti and other repairs to the siding. Siding maintenance is scheduled for the Fall of 2020.

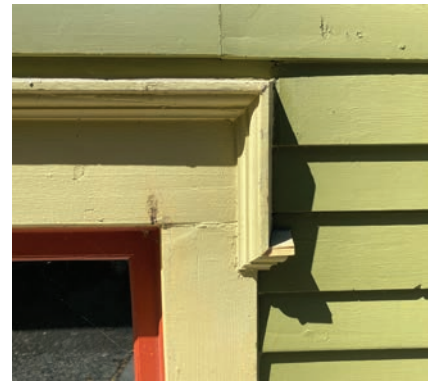
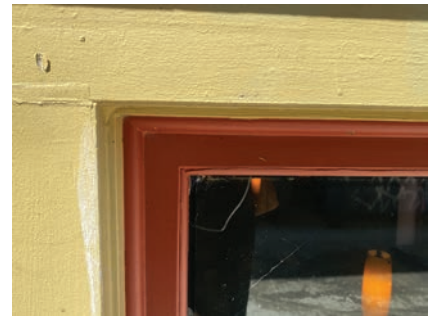
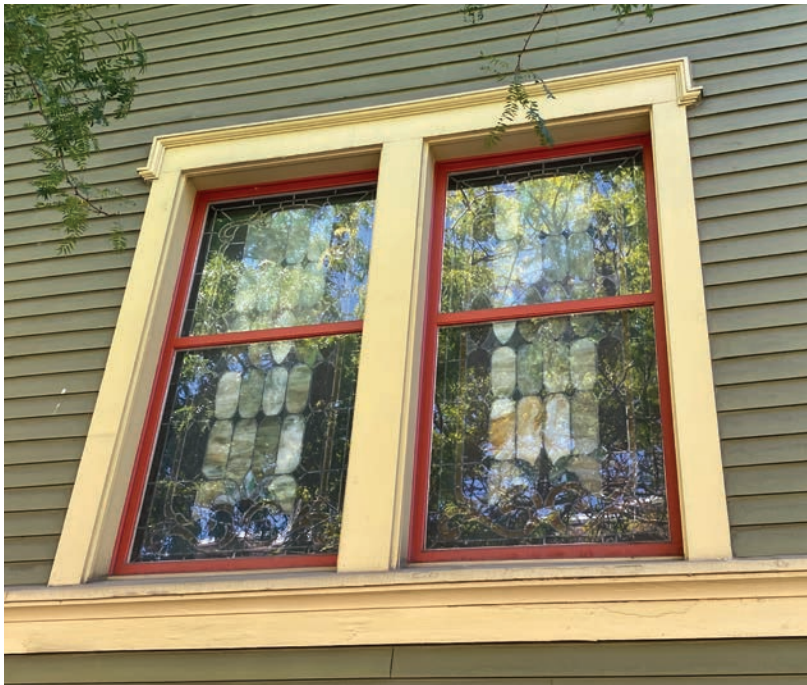
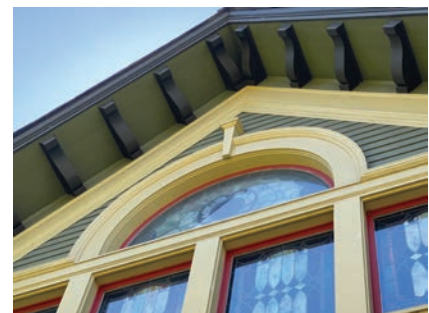
The windows reflect the original design intent of the building, although they contain some non-original components. We found that the condition of the paint was good to excellent, the condition of the frame and sill was excellent, the condition of the sash was excellent, there were no evident glazing problems at the exterior, and the overall condition was good to excellent.

Photos above show details of windows at alley. Photos to the left and below show windows at northern facade

The window rehabilitation included new compatible wood sashes to accommodate double glazing which protects the historic stained glass.

Re-caulking of the windows is scheduled maintenance for the Fall of 2020.

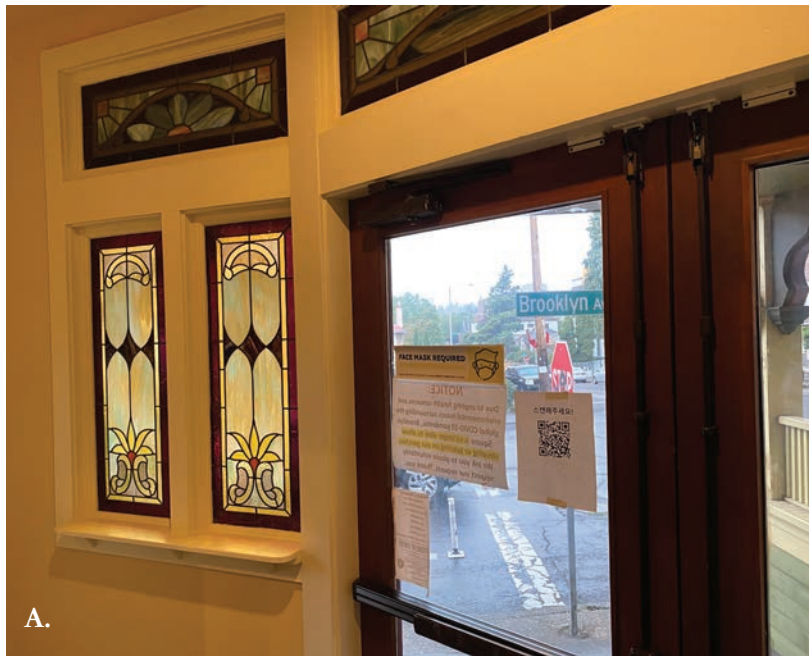
A. Non-original entry doors with rehabilitated original stained-glass windows.

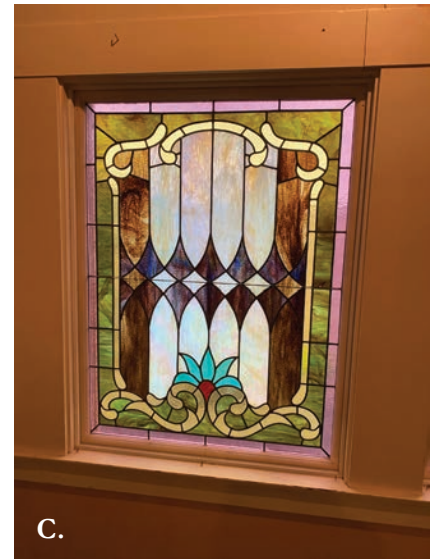
C. Rehabilitated original stained-glass window

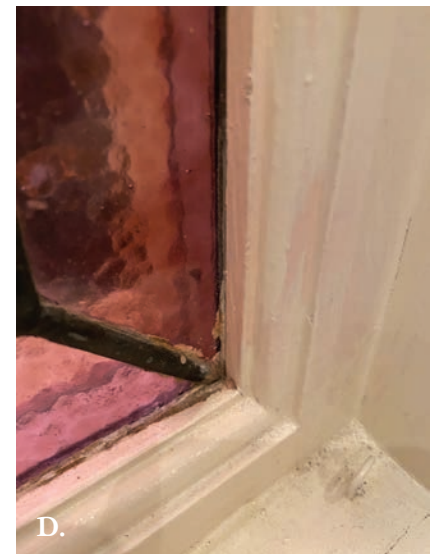
D. Replacement sash at rehabilitated stained-glass window, which holds double glazing for protective pane at exterior.

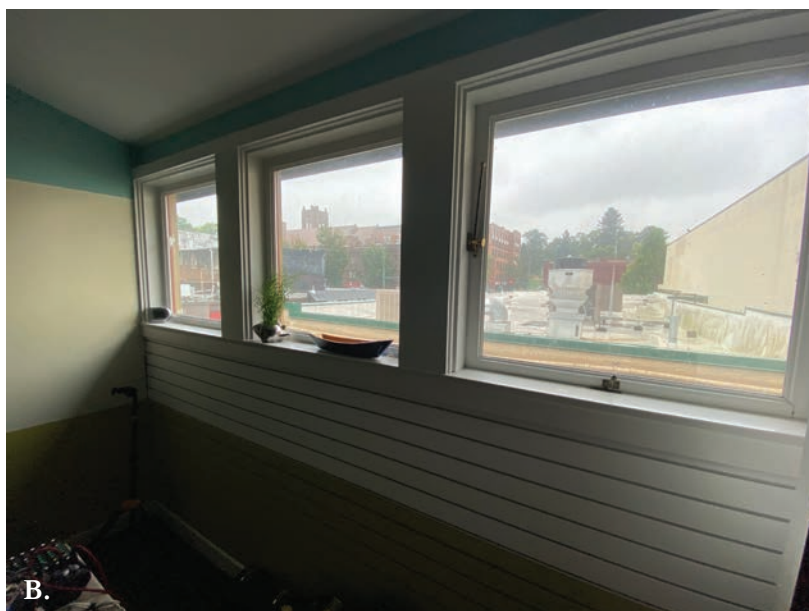
B. Non-original dormer windows at the eastern facade in the church office

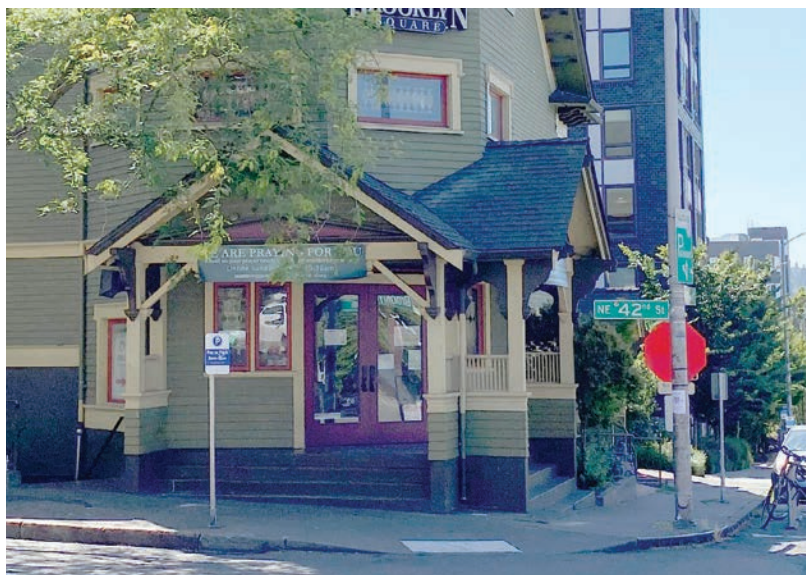
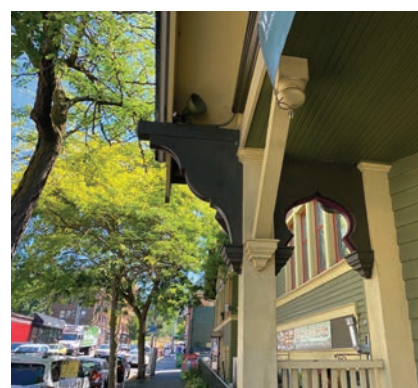
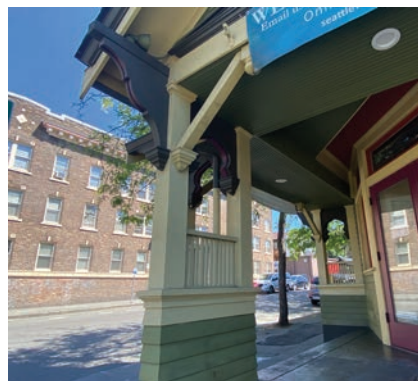
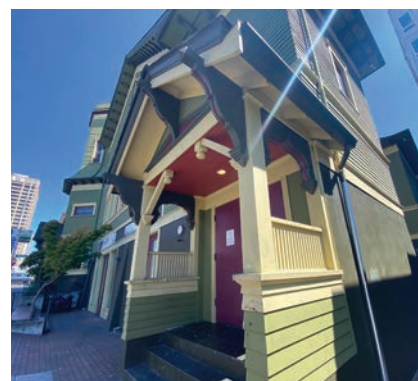
The porches on the subject building are in generally good condition. The porch posts provide adequate support. The roofing and drainage systems keep water away from the wood structures of the porch. The flooring is painted concrete, and is in good condition. There is no evidence of general wood decay, nor is there evidence of cracks or joints in the woodwork. There is no peeling paint. The nearby street trees do not pose a threat to the porches.

Northwestern porch pictured in image above, southern porch in image to the right

Northwestern porch pictured in images above and below

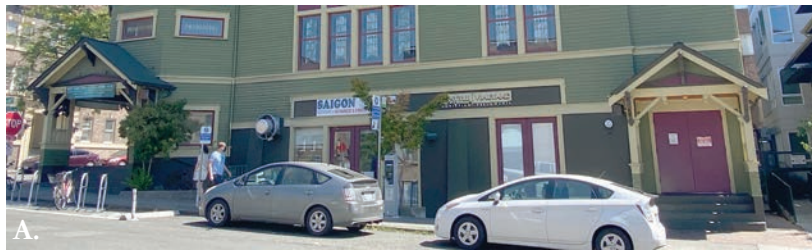
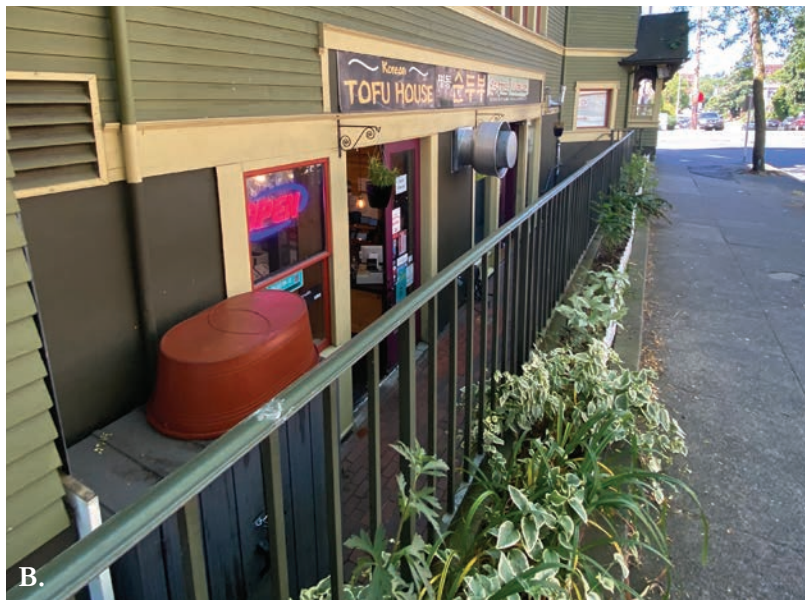
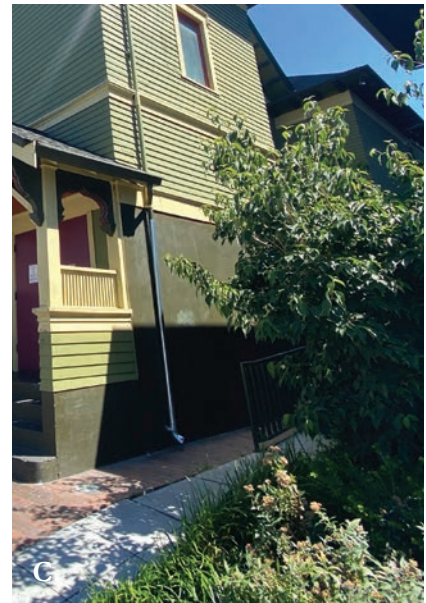
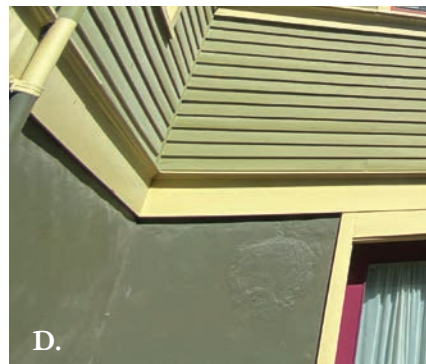
The current configuration of the basement walls dates from the 1983 remodel when the Landmarks Preservation Board granted a Certificate of Approval to add storefront retail to the building among other rehabilitation items. The concrete foundation has been coated with a cementitious parging and painted. The maintenance of the paint, and control of the roof water run-off and maintenance of the gutters has prevented any major issues with water intrusion and delamination. The basement and foundation walls are in good condition, as are their exterior coatings.

- A. Western facade of subject building
- B. Northern facade areaway of subject building
- C. Southern facade of subject building
- D. Detail of materials at southern facade, painted parge coated concrete, with wood trim and wood siding above.

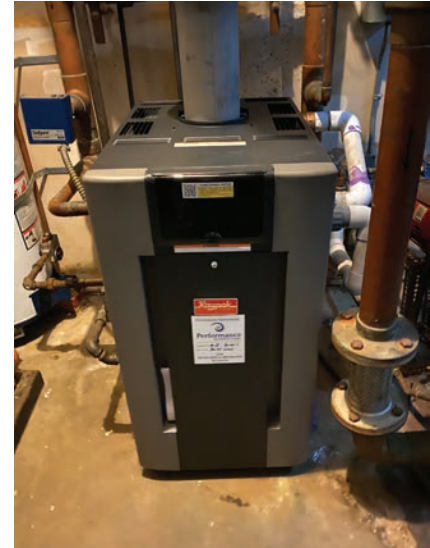
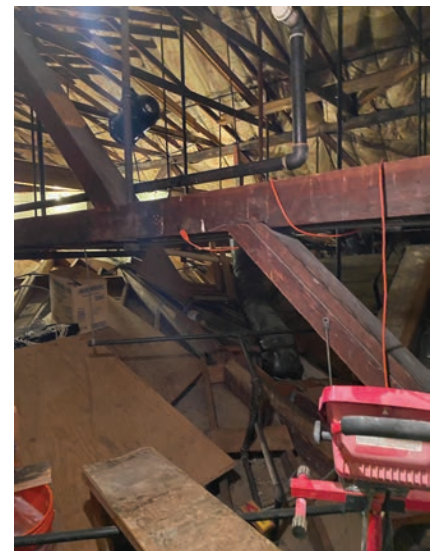
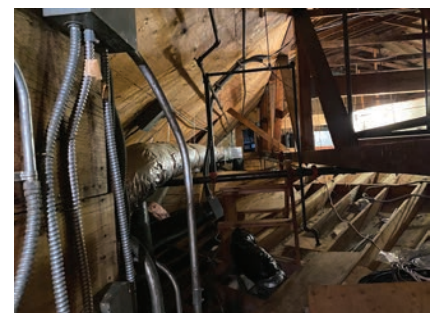
The mechanical system has been continuously updated, with the mechanics for air handling, air conditioning, and the boiler all installed within the last 10 years, along with some of the ducting at the attic. However, much of the ductwork was installed in 1983 during the major rehabilitation.

Photos to the right: views of fire suppression plumbing, electrical conduit, and new insulated duct at attic.

Above: new boiler.
